**Chicora Research Contribution 542**

# **HISTORICAL SYNOPSIS, RECORDATION, AND ASSESSMENT OF GRAVESTONES IN THE TOGUS WEST NATIONAL CEMETERY, TOGUS, MAINE**

National Cemetery Administration  
U.S. Department of Veterans Affairs  
810 Vermont Avenue, NW  
Washington, DC 20420

March 2012

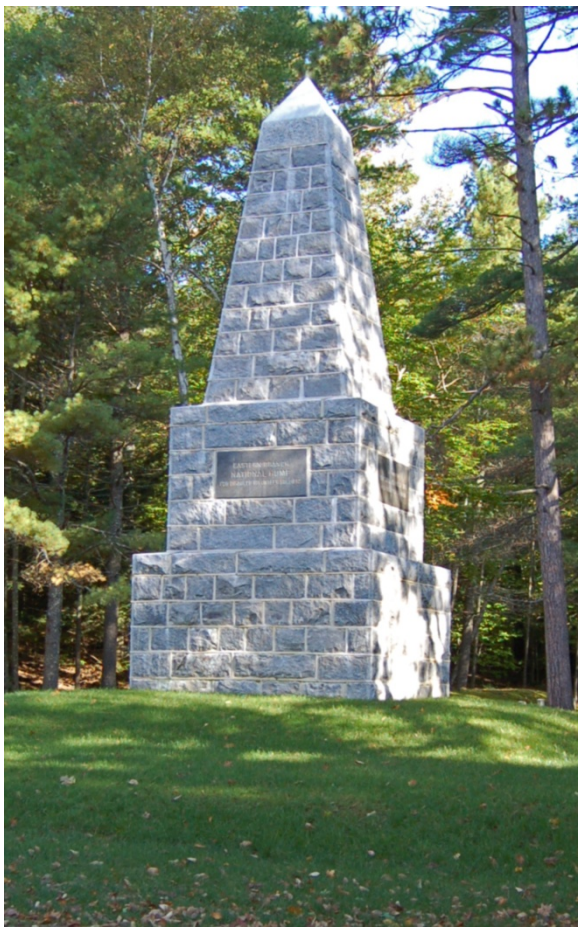
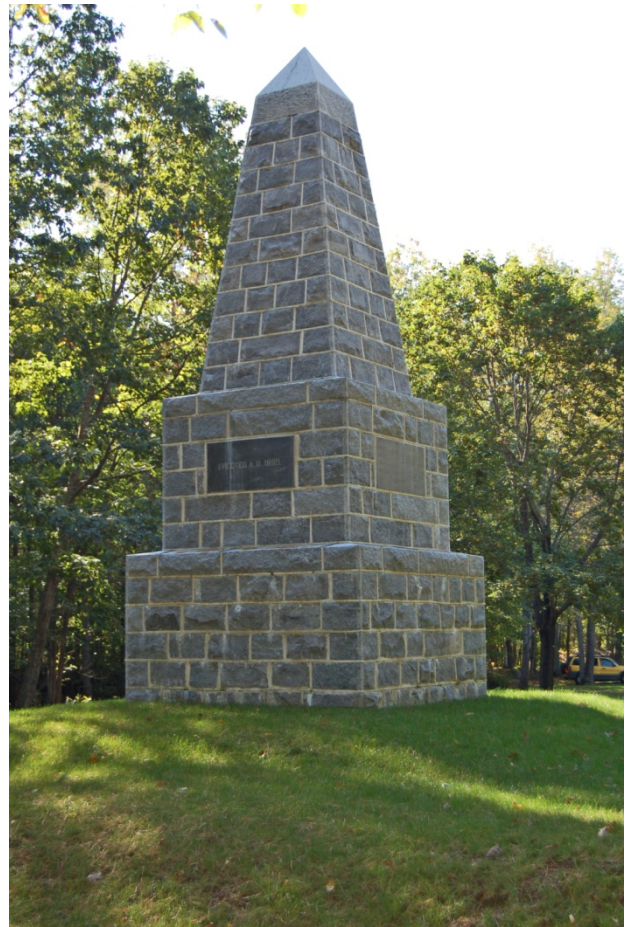
Figure 38. Soldier's Monument after treatments, oblique views to the north and south.

A number of weep holes have been installed in the monument to provide drainage for water that enters the monument core. Water intrusion was apparently a significant issue in the failure of the original monument.

Several issues warrant attention. The first is that the relatively shaded location of the monument tends to promote biological growth. We recommend that the VA initiate a yearly program of cleaning the monument with a quaternary ammonium biocide such as Cathedral Stone's D/2 or Prosoco's BioWash. In either case the monument should be thoroughly prewetted, the cleaner applied undiluted and allowed to dwell for 15-20 minutes, and then entirely rinsed off. Scrubbing using soft bristle brushes is useful during the dwell period. The pressure of the water applied to the monument should not exceed 90 psi.

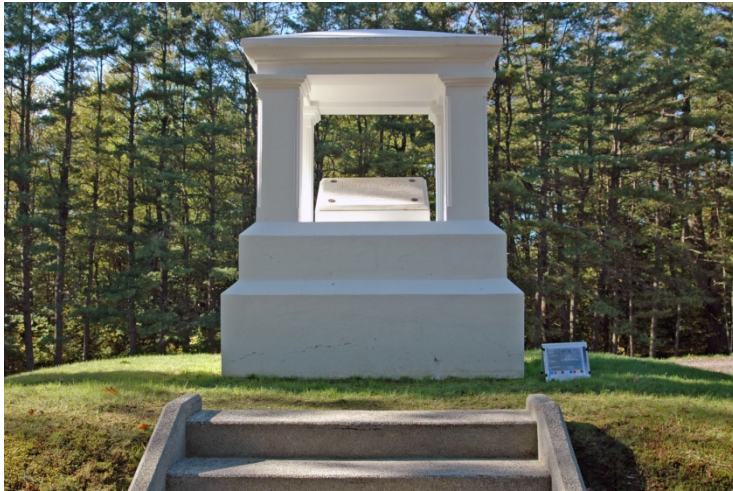
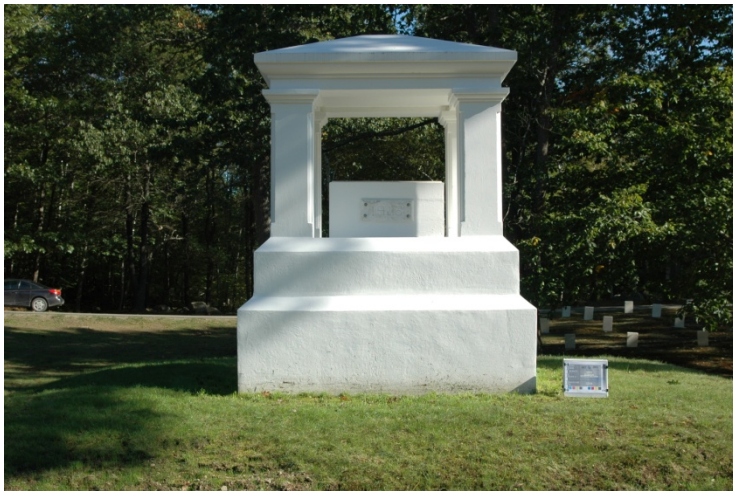
Figure 41. Spanish-American War Monument, looking west and east.

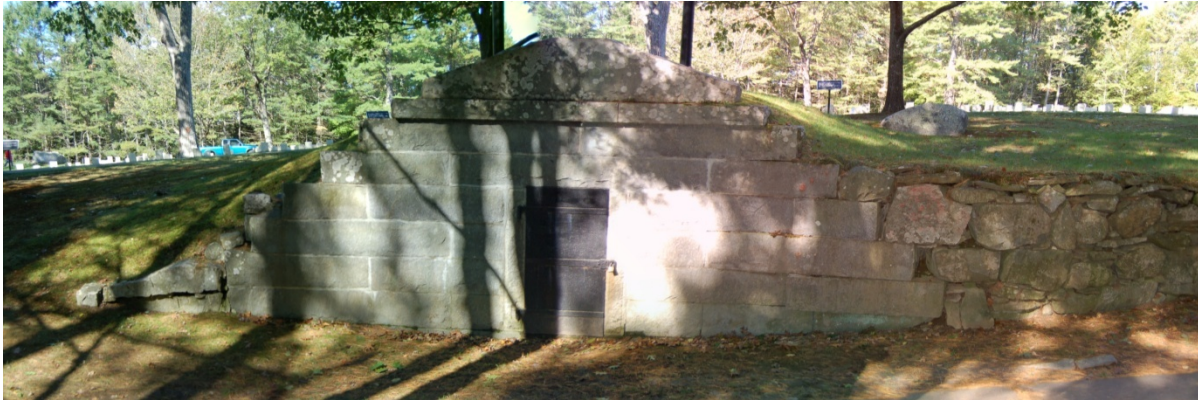
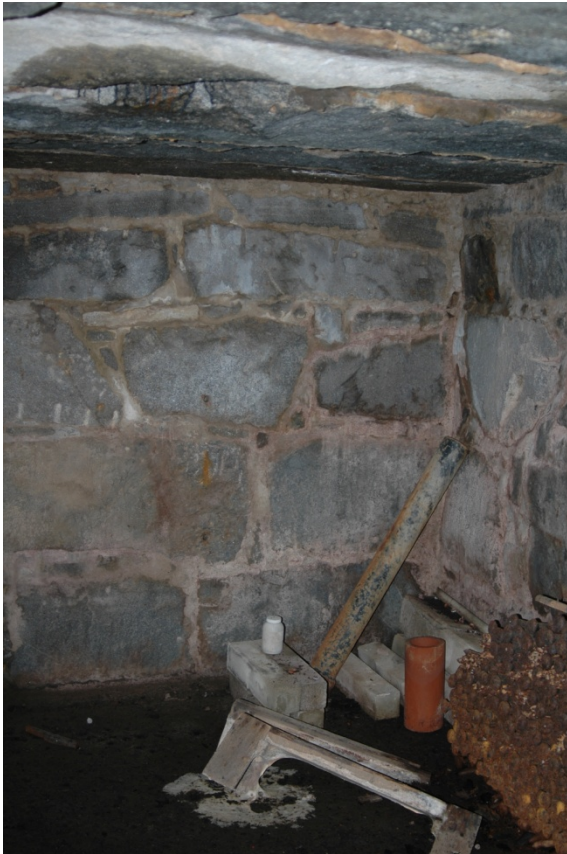
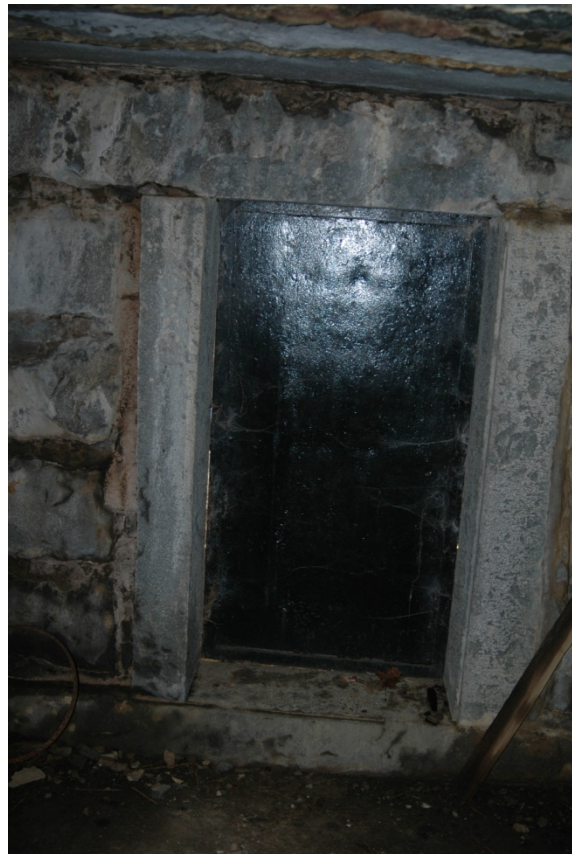
The vault has had the mortar joints repaired on at least two occasions, with the recent pointing exhibiting strikingly poor workmanship. Areas that appear original have beaded joints. The

Figure 44. Granite vault at West Cemetery. The upper photo shows the vault looking west; note how the vault is tied into a dry laid stone wall at the right (north). The lower left photo shows the interior construction, looking at the northwest corner. One of two stacks of flag holders are shown along the north wall. The lower right photo shows the interior construction at the door on the east wall.

Of equal importance, however, is the need to repair the dry laid stone wall where it ties into the existing tomb. For a distance of approximately 6-10 feet the wall is bowed outward with stones being displaced. This damage is almost certainly the result of soil pressure behind the wall since its construction over 150 years ago.

Dry stone walls do rely on the skill of the craftsman. We strongly recommend that the VA contract with the Dry Stone Conservancy for the rebuilding of this wall. Recently the Conservancy formed a cooperative agreement with the National Park Service for the repair of dry stone walls at the Weir Farm National Historic Site with the work also providing building skills to NPS staff. The VA

Most critical is that the wall be repaired using appropriate dry stone walling techniques and that as little of the original fabric be disturbed as possible.

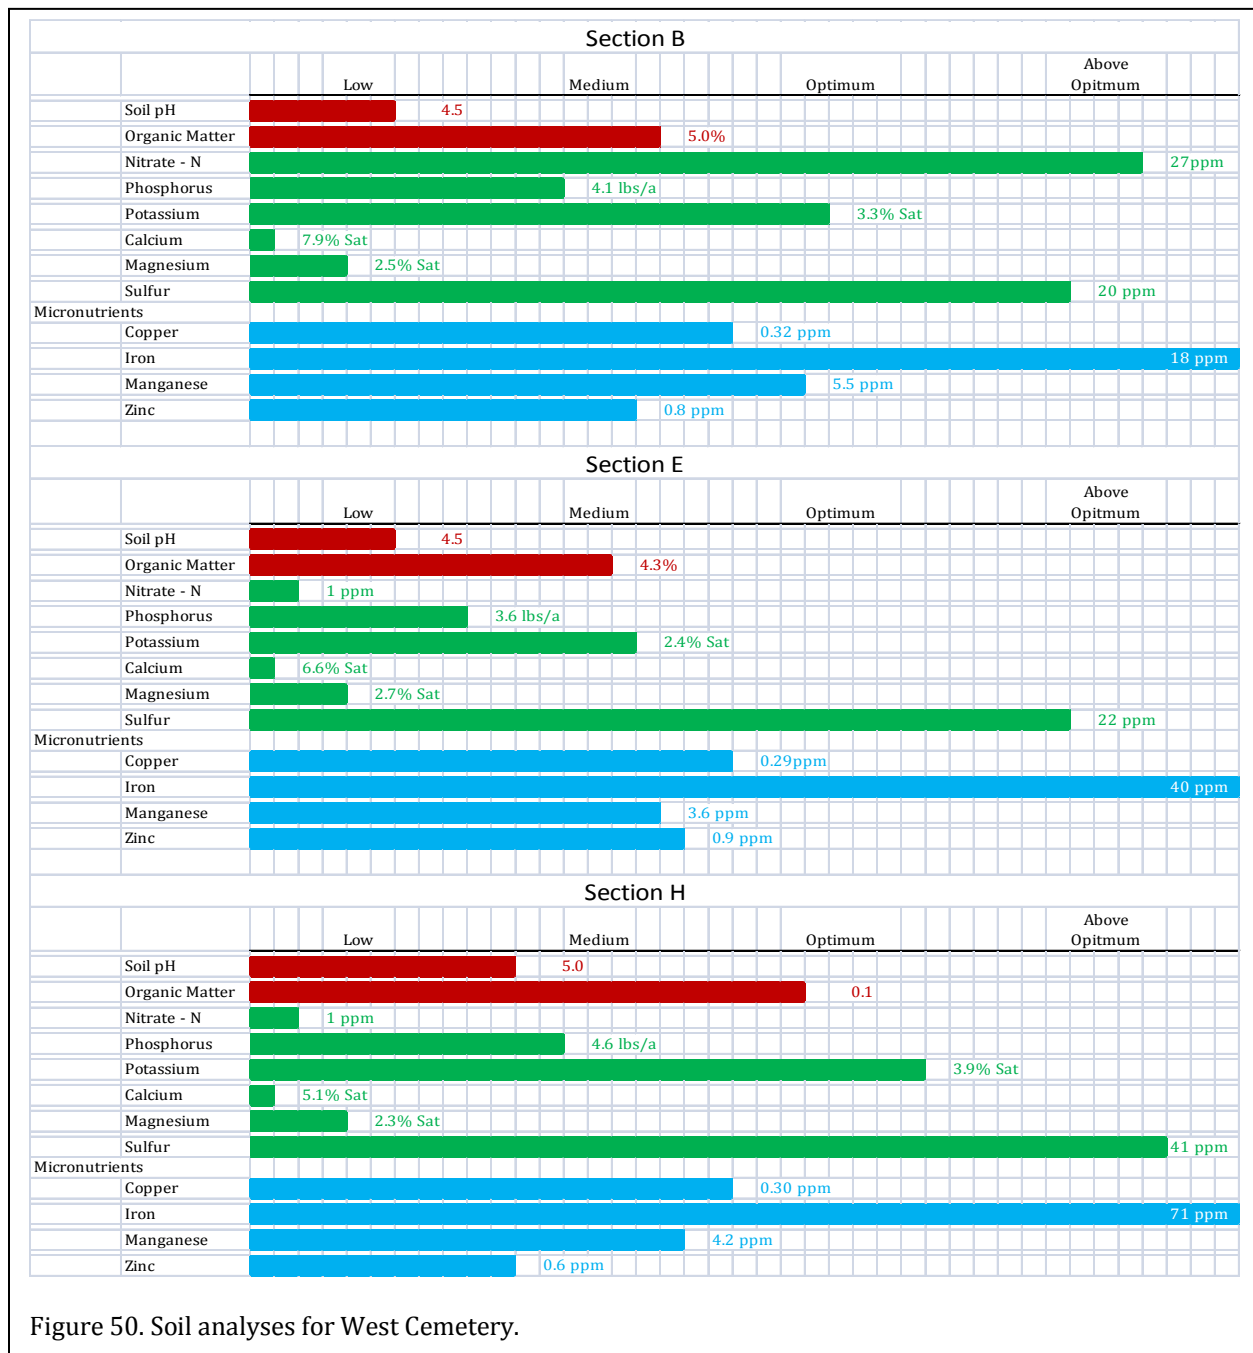
Results of macro and micronutrient analysis for the three samples are shown in Figure 50. The soil pH for all three areas is acidic, between 4.5 and 5.0. Most grasses desire a pH of 6.0. In addition, this pH can cause noticeable damage to marble in a relatively short period. The acidic nature of the soil is reflected in the very low – almost nonexistent – calcium levels.

Figure 50. Soil analyses for West Cemetery.

The micronutrient levels in all three samples are very similar. Iron is found in very high levels. This may be the result of the low pH since as soil pH drops it sometimes will create an excess of available iron.

Recommendations to improve the soil include the application of lime to raise the soil pH to 6.0. In all cases lime topdressing should be limited to no more than 100 pounds per 1,000 square feet per year. To assist in developing the magnesium levels in the soils it is recommended that a magnesium lime be used.

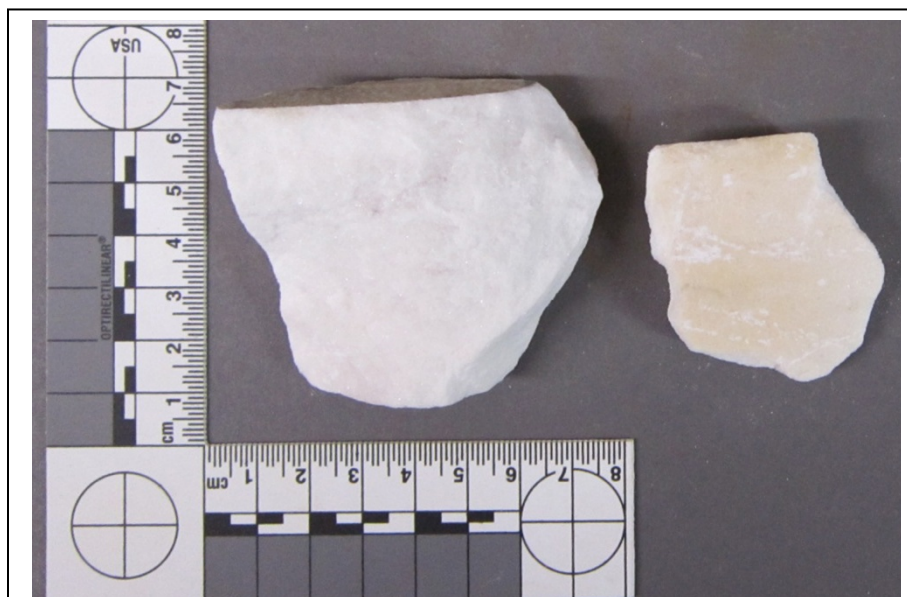
monument in the cemetery. Two samples, both from the same socket, were supplied in order that a quality control duplicate was available if needed. Both samples came from the same stone and were visually identical. They were very fine grained and pure white (Munsell N9). Where the stone had been exposed, it had taken on a slight yellowish cast (note the right specimen in Figure 52 below).

Figure 52. Samples submitted for analysis.

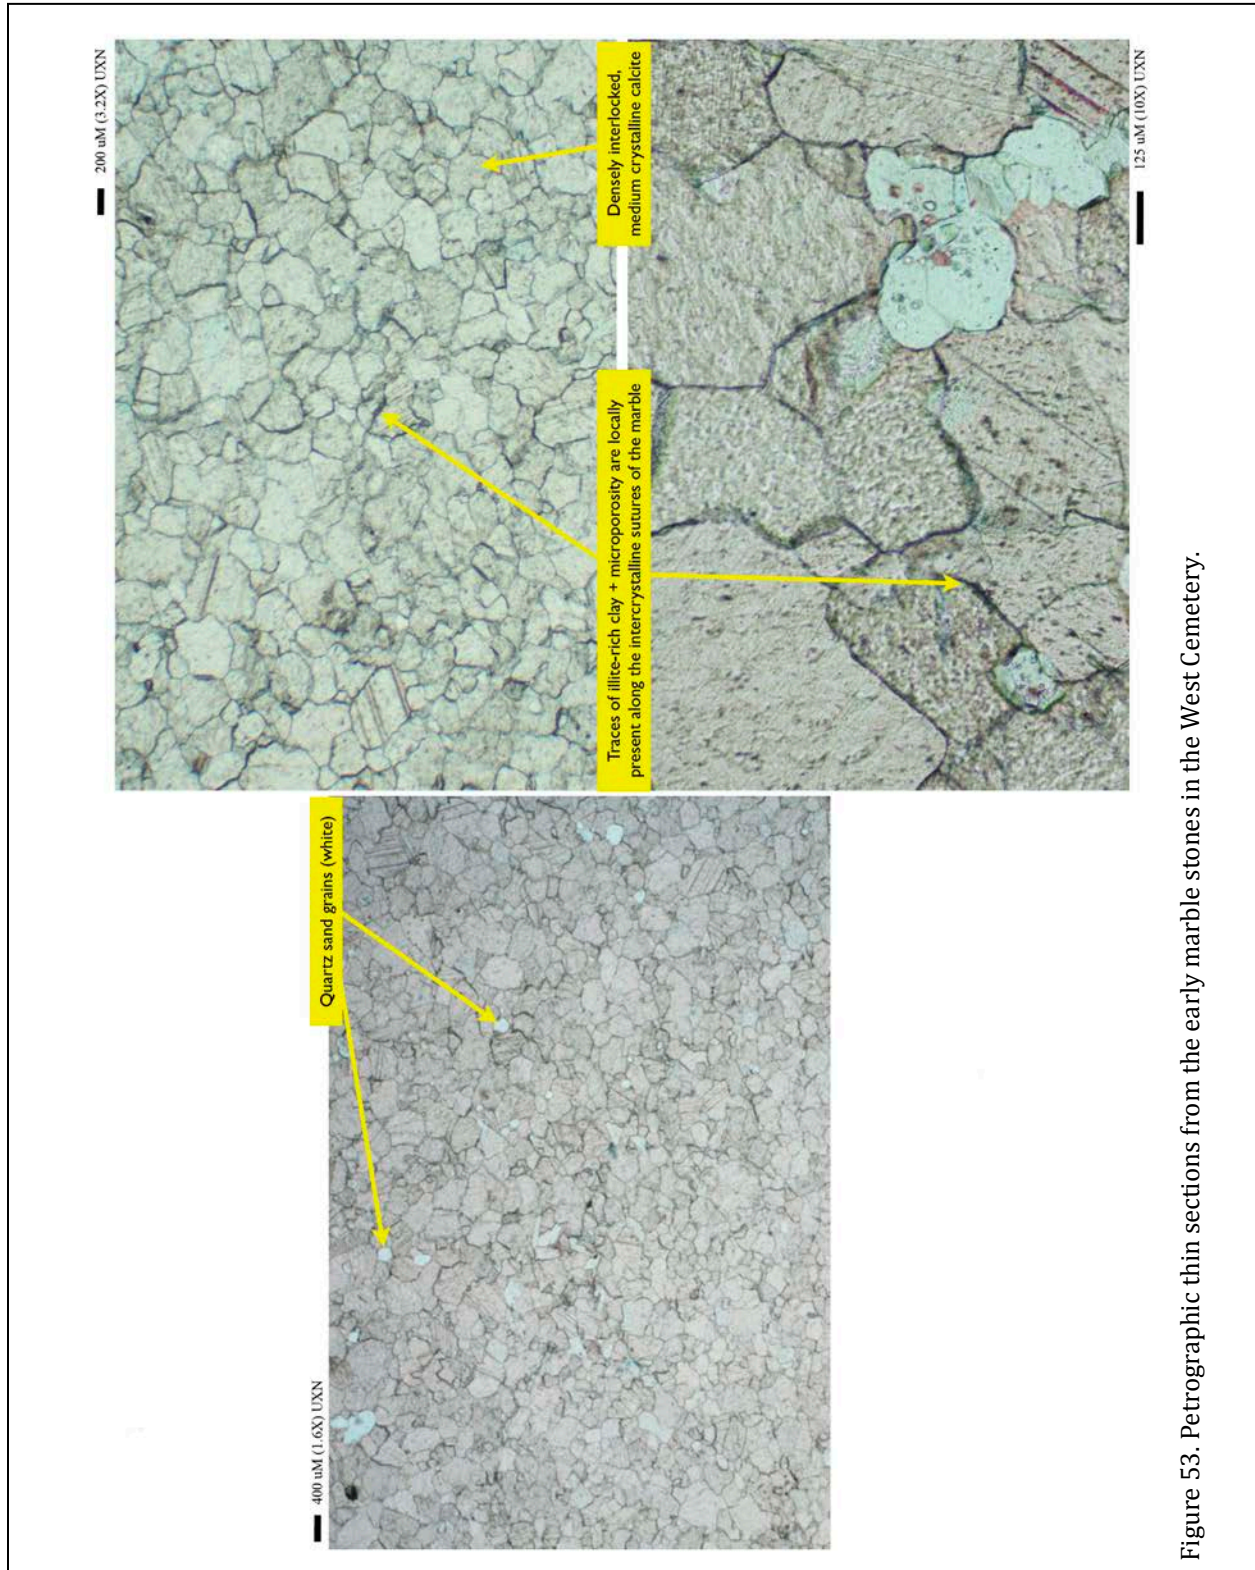
Figure 53. Petrographic thin sections from the early marble stones in the West Cemetery.

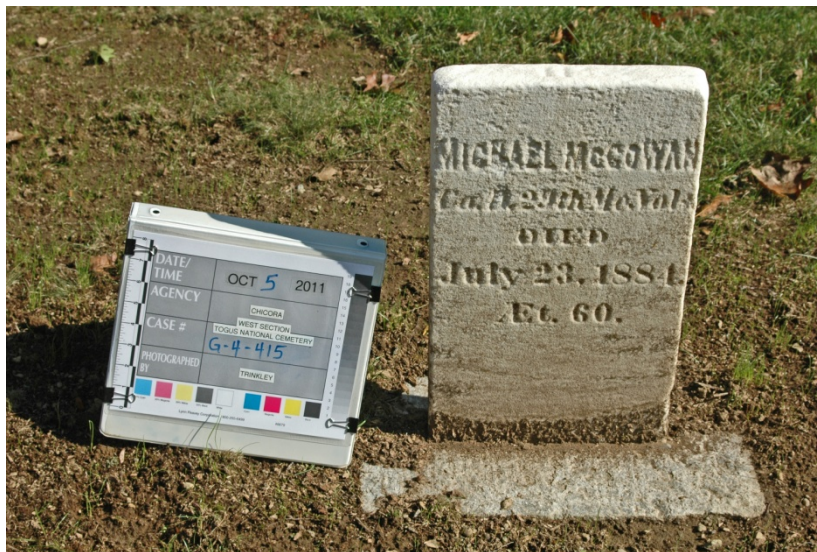
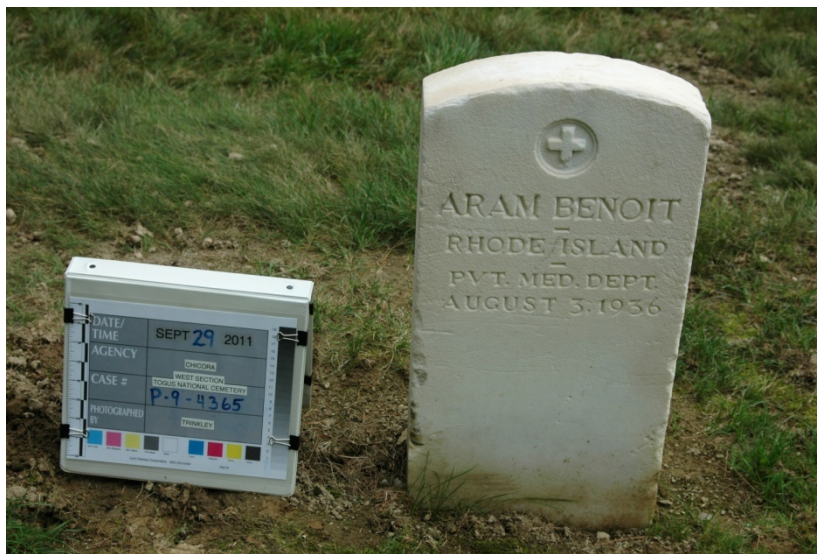
Figure 59. Eroded stones in West Cemetery. Upper stone shows badly eroded C stone. The lower photo shows erosion on the upper half of the D stone where it has been exposed. Note that the lower half of the stone, which until recently was below grade, exhibits less erosion.

A more prudent consolidation approach would be the use of the ProSoCo product HCT. This product is based on the formation of a well-adhered conversion layer, by chemical

reaction, on the carbonate mineral surfaces. Intergrowth of the conversion layer at points of grain contact results in some consolidating effect and the new layer is relatively acid-resistant. Since it is hydroxyl-functional, it provides for the attachment of ethyl silicate consolidates, if the choice is made for their use.

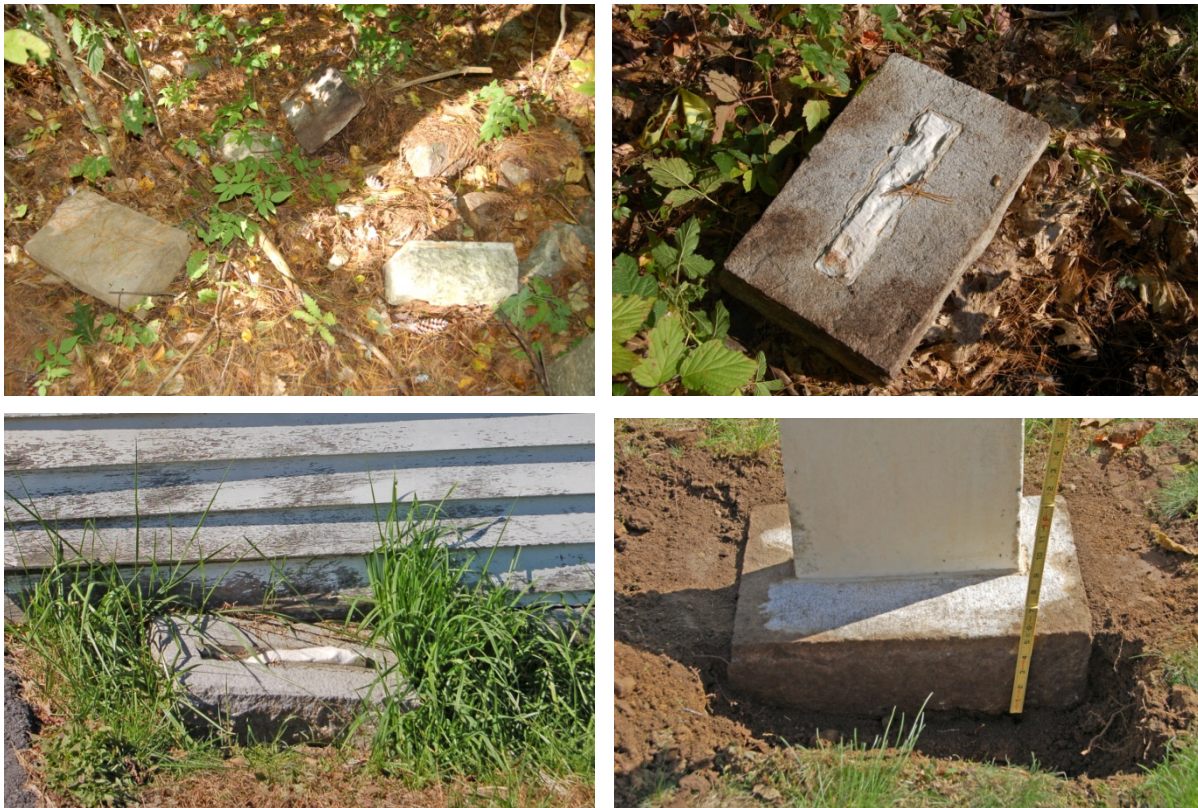
Figure 60. Granite bases. Upper photos show bases discarded in the woods. The lower left photo shows a base next to a building on the hospital campus. The lower right photo shows one of several excavated stones being measured.
